## Investigation Summary Report Update 3

Date: 12 December 2017

This investigation is into the activities of heavy vehicle specialist certifier Peter Wastney and was initiated following a crash on 27 August 2017, where the catastrophic failure of a drawbeam on a truck JWN197 resulted in the detached trailer travelling a significant distance before coming to rest against a bank.

**RE: Drawbeam failure – Registration JWN197**

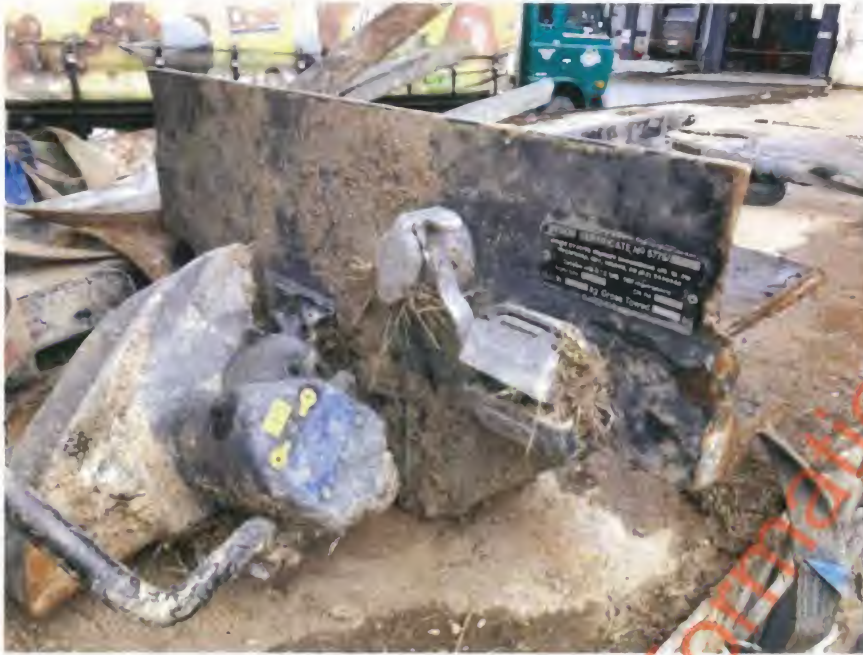
Figure 3 Drawbeam front weldment

Inspection of the truck found that the drawbeam front weldment had separated from the side plates which affix the drawbeam to the chassis, Figure 2. The front weldment is made up of the front plate and upper and lower stiffeners, Figure 3.

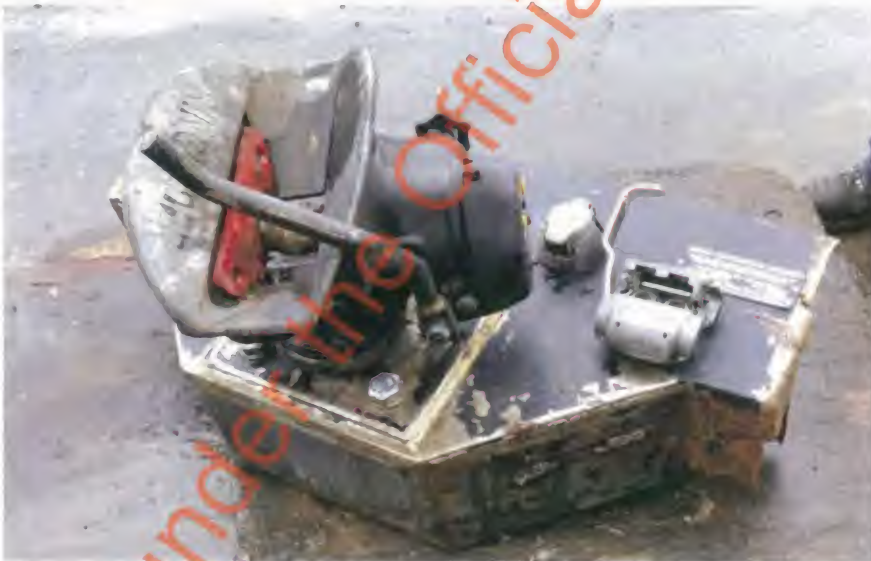
Figure 4 Drawbeam ready for detailed inspection

The drawbeam weldment was water blasted to remove soil and measured in detail. Inspection of the weldment found the separation in the drawbeam had occurred along the edges of the welded connections.

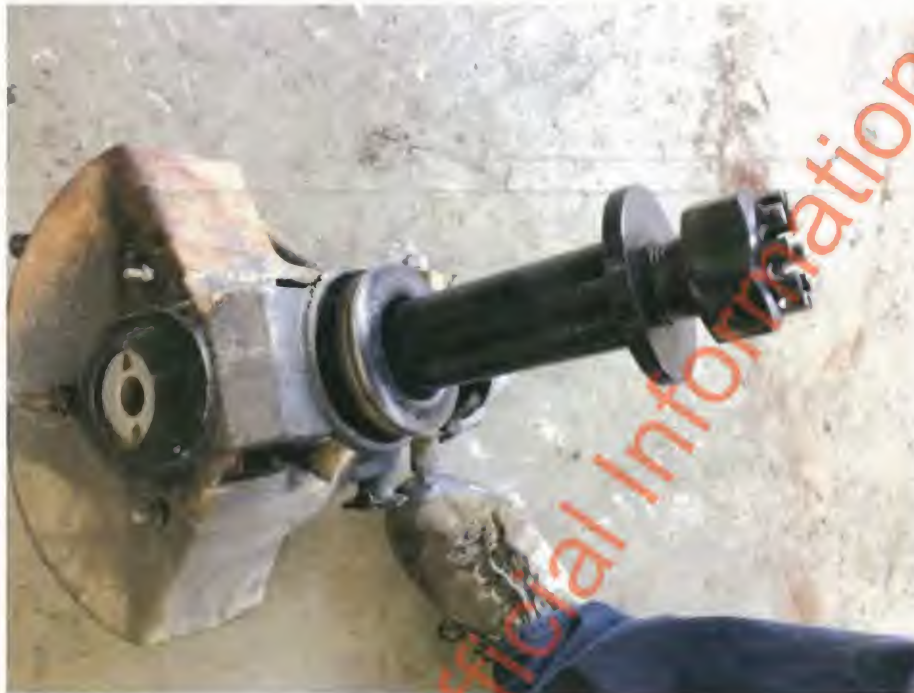
Figure 7 Ringfeder 5050 after removal

The drawbeam coupling, a Ringfeder 5050, was examined and found to be functioning correctly. The bolt group between the coupling and drawbeam was unbolted and found to be in good order.

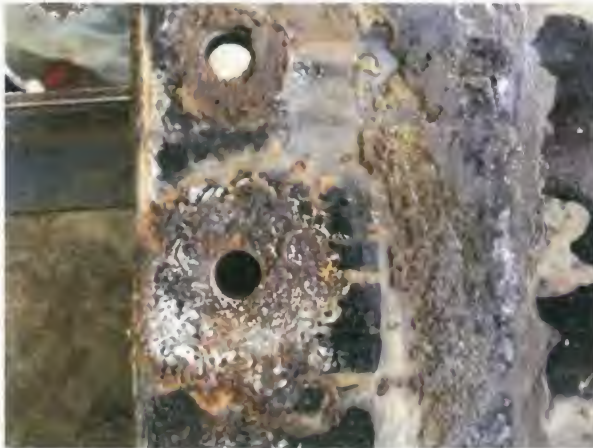
Figure 14 Swarf between drawbeam and truck side plates

It is apparent the drawbeam, chassis and subframe attachment plates were drilled in situ to facilitate alignment. While this is reasonable practice, a significant amount of steel swarf

was left between the plates, Figure 14. This swarf would affect the ability to maintain torque in the bolt group. The swarf accumulation would be difficult to identify during the inspection but does speak to the competency of the fabricator.

AS 3990:1993 states all defects on the surfaces of contact which prevent the solid seating of the bolt joint component shall be removed, clauses 10.3.4.3 and G1.2.1. This includes burrs, weld interference, and other defects such as swarf.

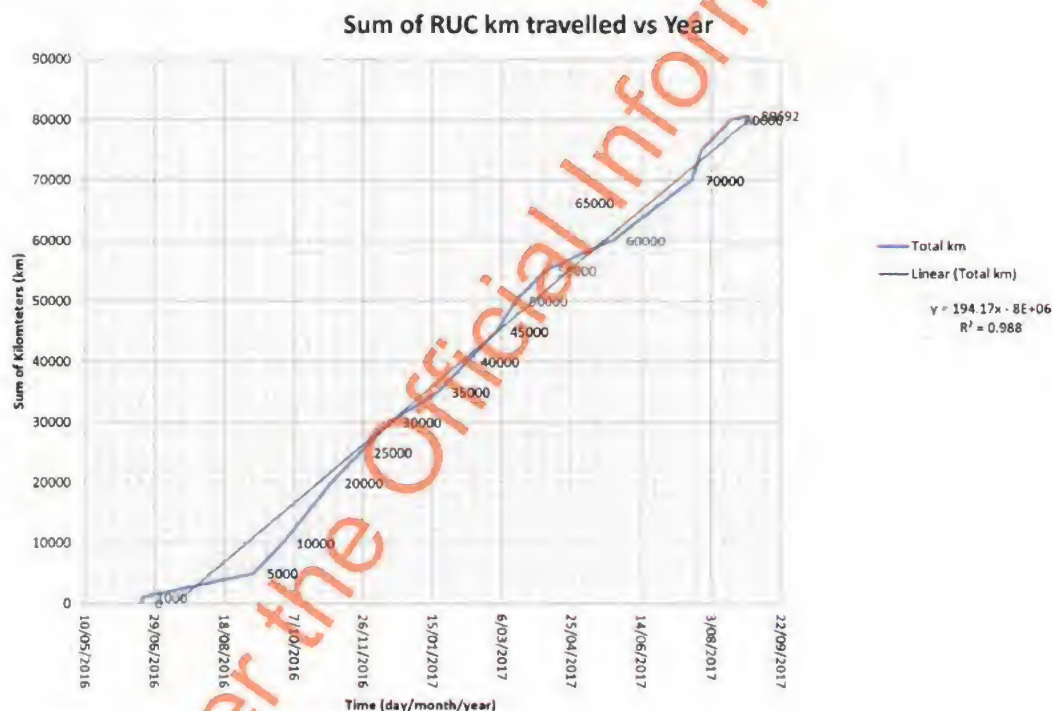
Figure 16 RUC history graph

A review of the trucks road user charges (RUC) history and the vehicle hubometer established the kilometres travelled by the vehicle since entering service, Figure 16. The RUC history shows the use of the vehicle has been relatively constant. At the time of the accident, the truck had travelled approximately 80,000 km.

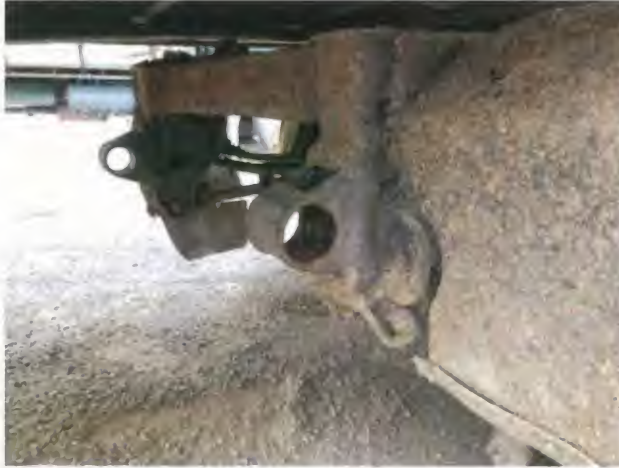
The trailer dolly, drawbar and hinge connection were examined and found to be in reasonable order given the accident. The drawbar tow-eye and trailer hinge attachments showed no evidence of failure.

The trailer braking system was tested using a brake roller tester. The results showed the vehicle brakes were deficient. Further investigation is ongoing.

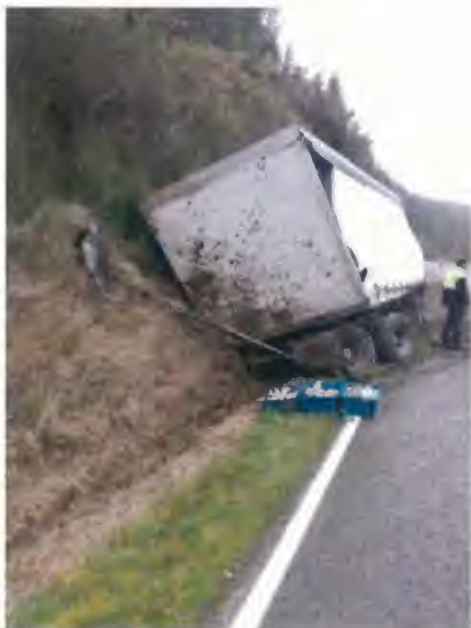
Figure 21 Accident scene photo

Several photos provided that were taken before the vehicle recovery commenced, show the drawbar and front segment of the drawbeam still attached, Figure 21 and Figure 22.

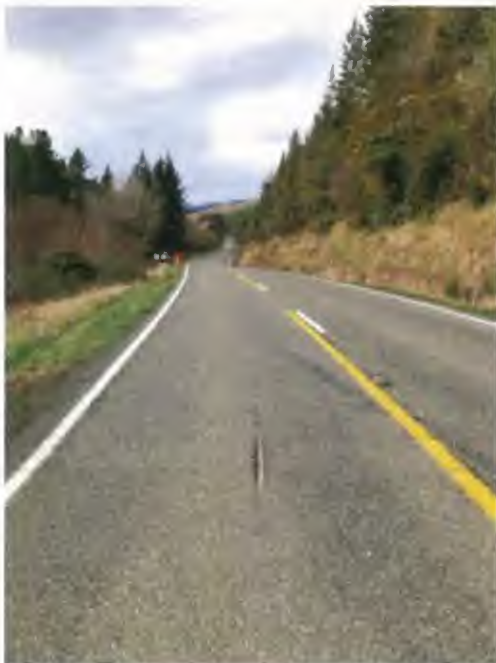
Figure 23 Road section where accident occurred

The road segment where the accident occurred is on an off-camber downhill gradient with a slight left-hand bend. The speed limit for a heavy vehicle is 90 km/hr.

At the location where the trailer is reported to have separated from the truck, a prominent groove was found in the centre of the road lane, Figure 23 and Figure 24.

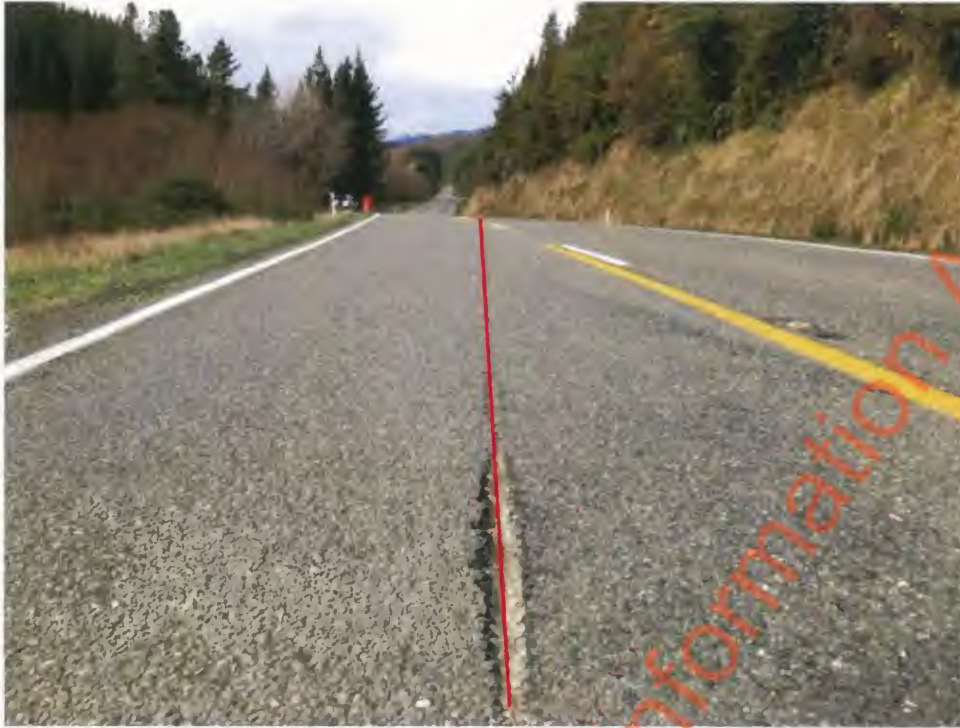
Figure 25 Groove centre line to embankment impact point

The groove's direction projects to the impact point between the trailer and the right-hand embankment where the trailer came to rest, Figure 25.

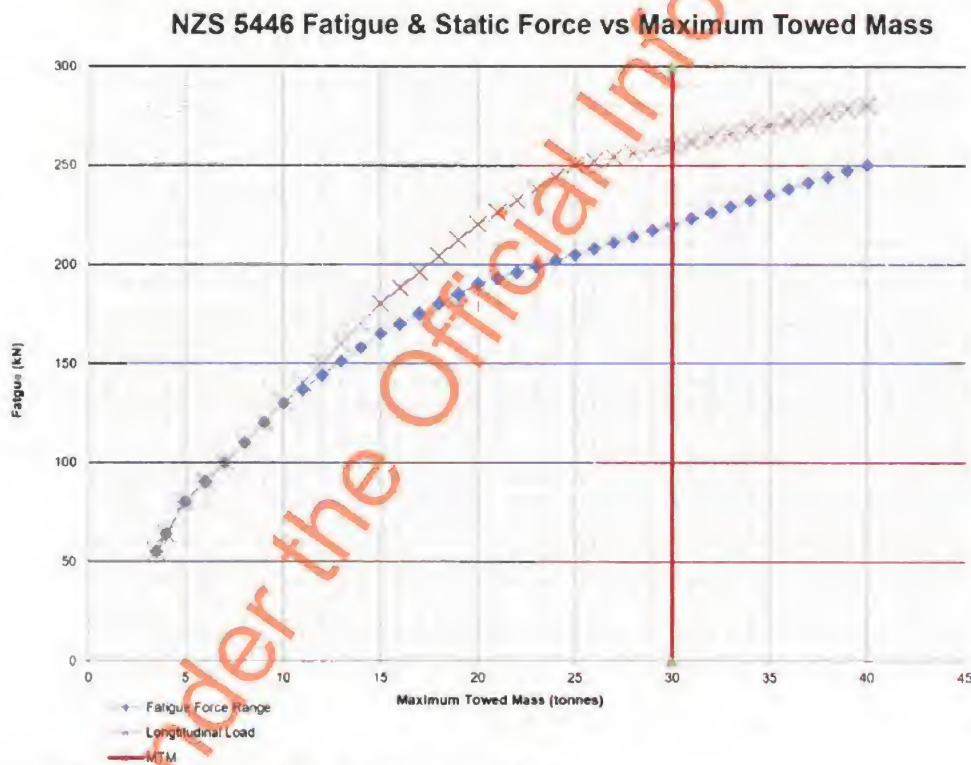
Figure 29 NZS 5446 Fatigue & Static Force versus MTM

Given a certified maximum towed mass of 30,000kg, the longitudinal force and fatigue force range is 260kN and 220kN respectively, Figure 29.

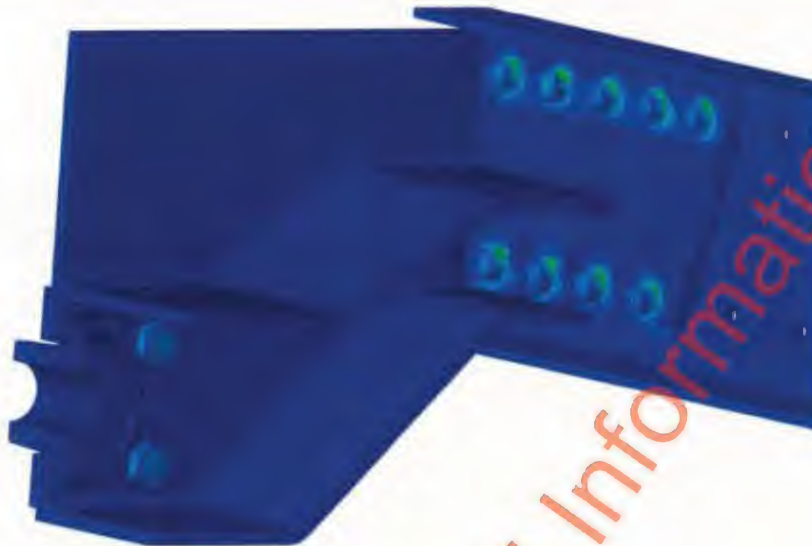
Figure 30 von Mises stress showing bolt pre-tension

The bolt pre-tensioning is applied in the initial step of all analysis, Figure 30. The bolt pretension was confirmed by measurement of von Mises stress in the bolt elements.

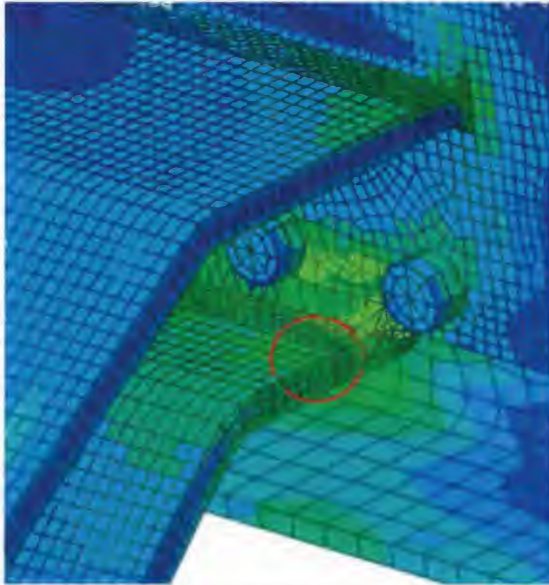
Figure 42 Stress measurement area

Given stress-life fatigue is calculated using nominal stress the stress concentration at the weld to parent interface is not used. Instead, as recommended by NAFEMS, the stress is taken in the parent metal adjacent to the weld, Figure 42 (NAFEMS, 2017a).

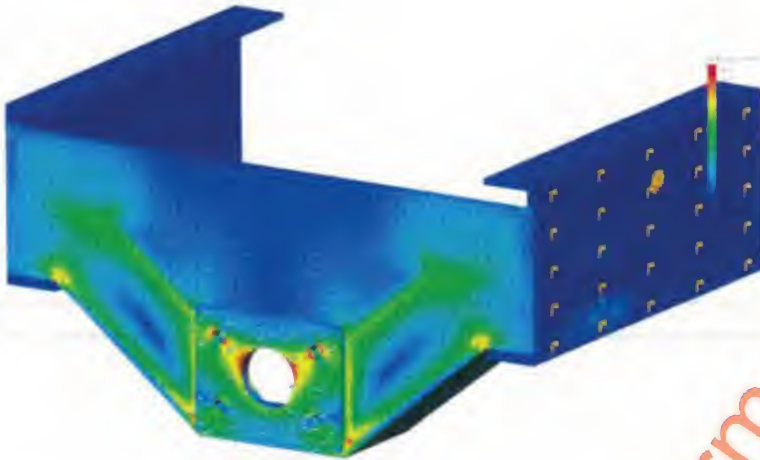
Figure 43 Certifiers drawbeam analysis - 220kN

Sandbox Consulting ran the certifiers FEA model using Solidworks 2017 simulation.

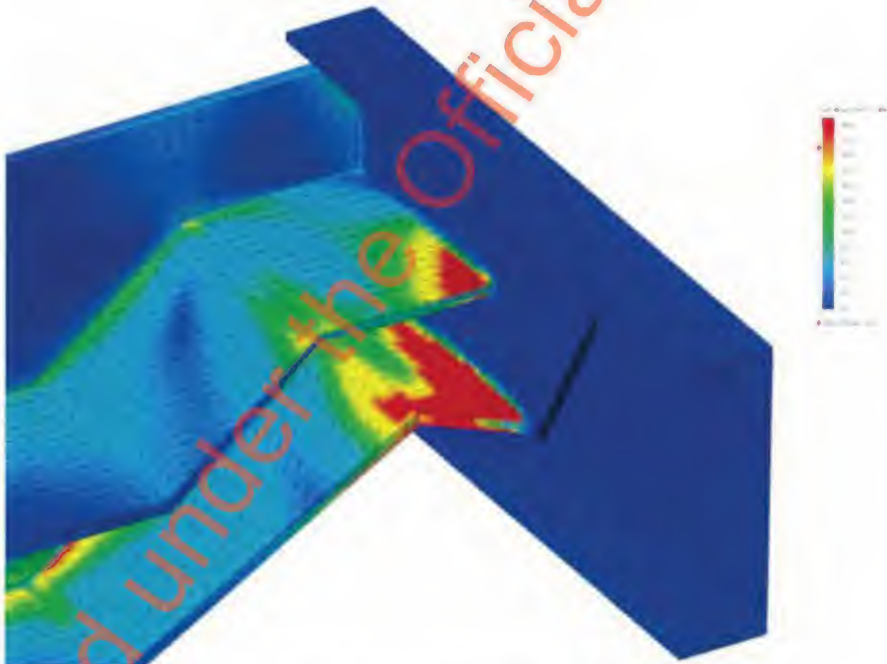
Figure 44 Certifiers drawbeam analysis - 220kN, rear view

Refinement of the finite element mesh was carried out in order to improve the accuracy of the results; this is good practice. Mesh improvement and convergence studies are an important part of validating FEA.

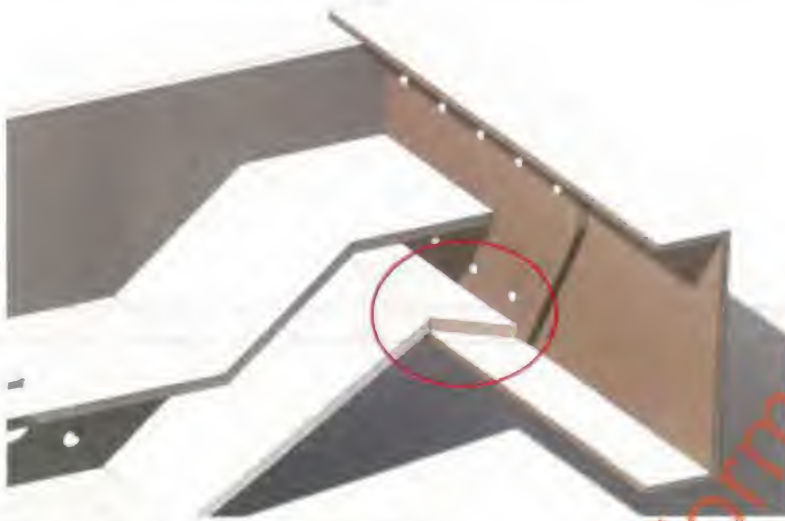
Figure 45 Certifiers drawbeam, rear view

The certifiers model has a different lower stiffener with extended rear gussets than the inspected drawbeam, Figure 45.

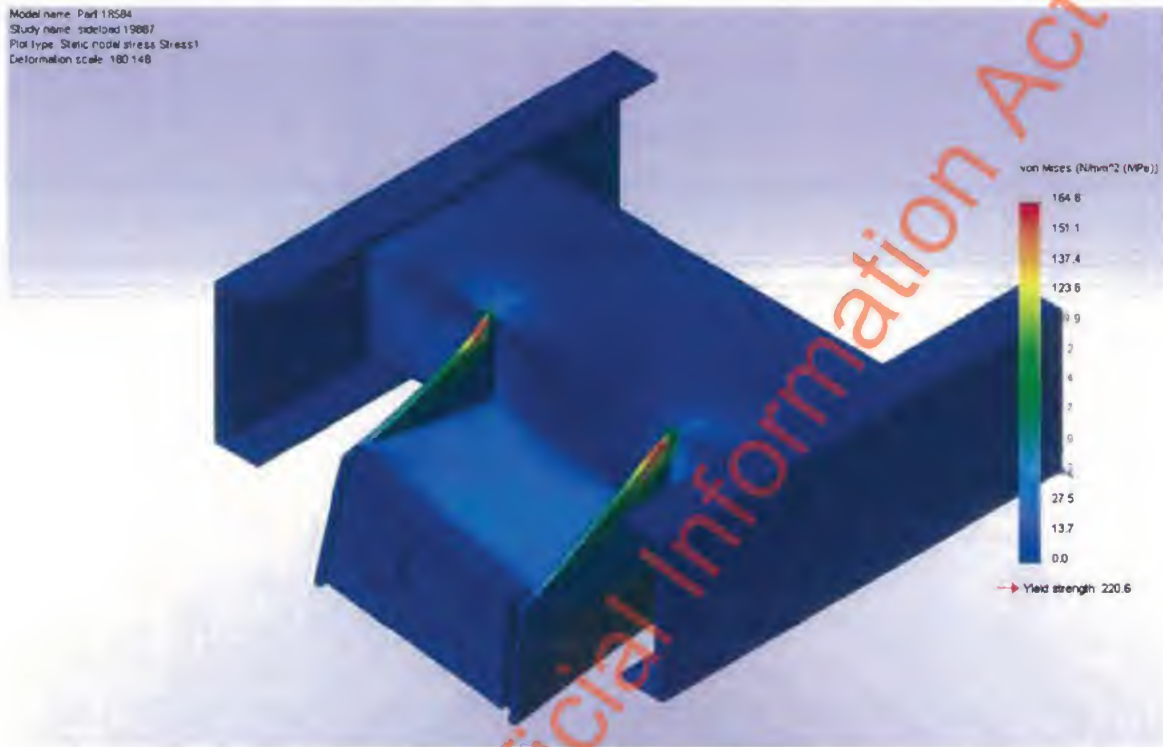
In particular the image below is from your certification file for LT400 607095. For fatigue compliance stress should be no more than 60% of yield strength according to AS 3990. For a yield strength of 220MPa that would be 132MPa, however the FEA image shows stress levels above this – in the region of 150MPa. Is this correct, and if so why did you proceed to certify the drawbeam?

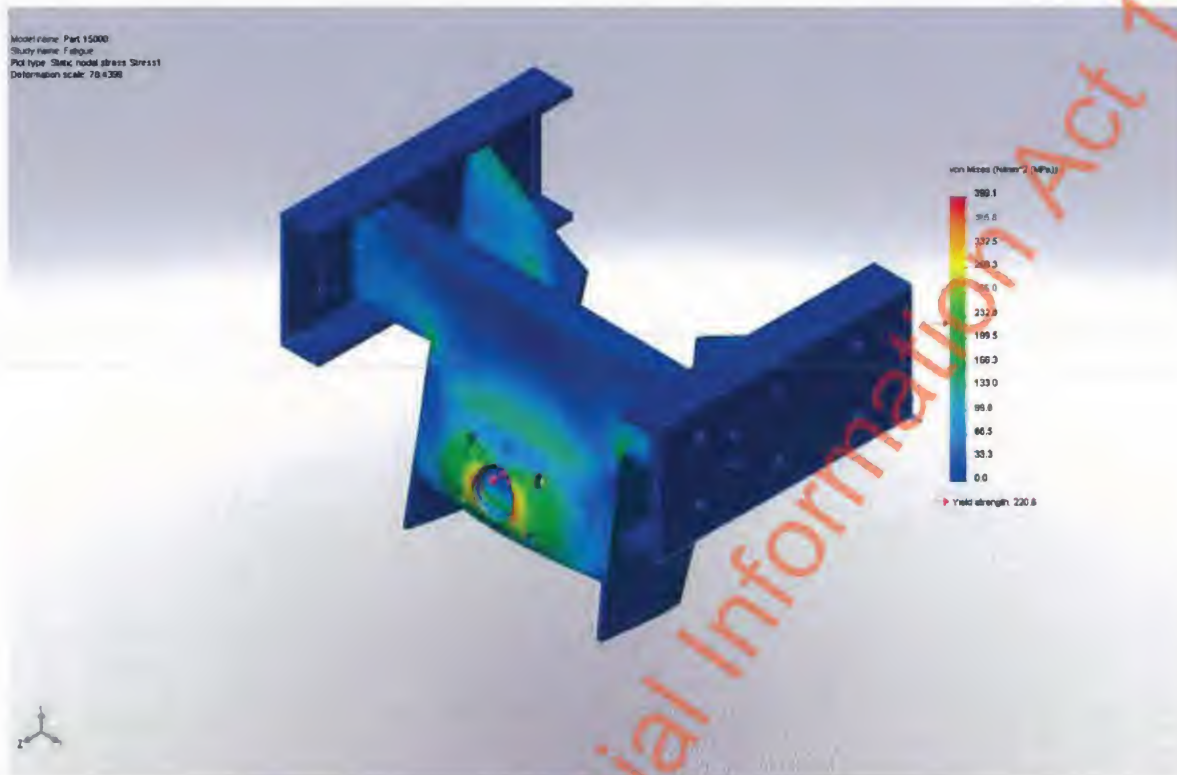
You included the following screen plot from analysis, and query stress levels being higher than 60% of yield.

This plot shows the loading as prescribed by NZS 5446 applied to the area bounded by the towing coupling flanges. This is not quite correct, as this area is clamped by the flanges. A more representative result would be obtained by applying this load as a rigidly applied load, or by modelling the actual coupling onto the drawbeam. However, both of these methods have drawbacks. It can be shown that so long as the section being bolted through is at least 16mm thick, there is no problem in the section of the drawbeam contained within the coupling flange meeting NZS 5446 loading. In analysing this plot, therefore, the stresses bounded by the coupling flange may be ignored. In this case, it can be seen that drawbeam stresses are actually within the 60% threshold of Yield Stress. If you have concerns about the strength of this drawbeam, perhaps you should also check Mills Tui File 197607, as the drawbeam was unchanged from this original certification.

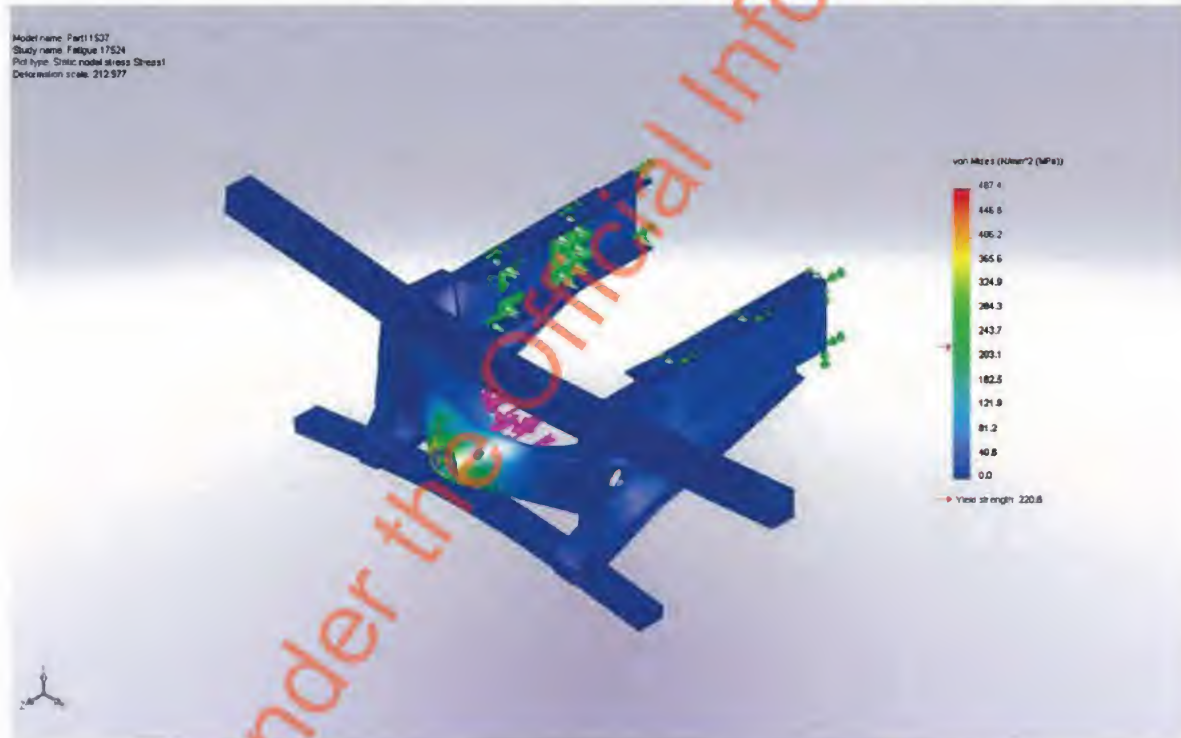
You included the following screen plot from analysis, and query stress levels being higher than 60% of yield.

This plot shows the loading as prescribed by NZS 5446 applied to the area bounded by the towing coupling flanges. This is not quite correct, as this area is clamped by the flanges. A more representative result would be obtained by applying this load as a rigidly applied load, or by modelling the actual coupling onto the drawbeam. However, both of these methods have drawbacks. It can be shown that so long as the section being bolted through is at least 16mm thick, there is no problem in the section of the drawbeam contained within the coupling flange meeting NZS 5446 loading. In analysing this plot, therefore, the stresses bounded by the coupling flange may be ignored. In this case, it can be seen that drawbeam stresses are actually within the 60% threshold of Yield Stress.

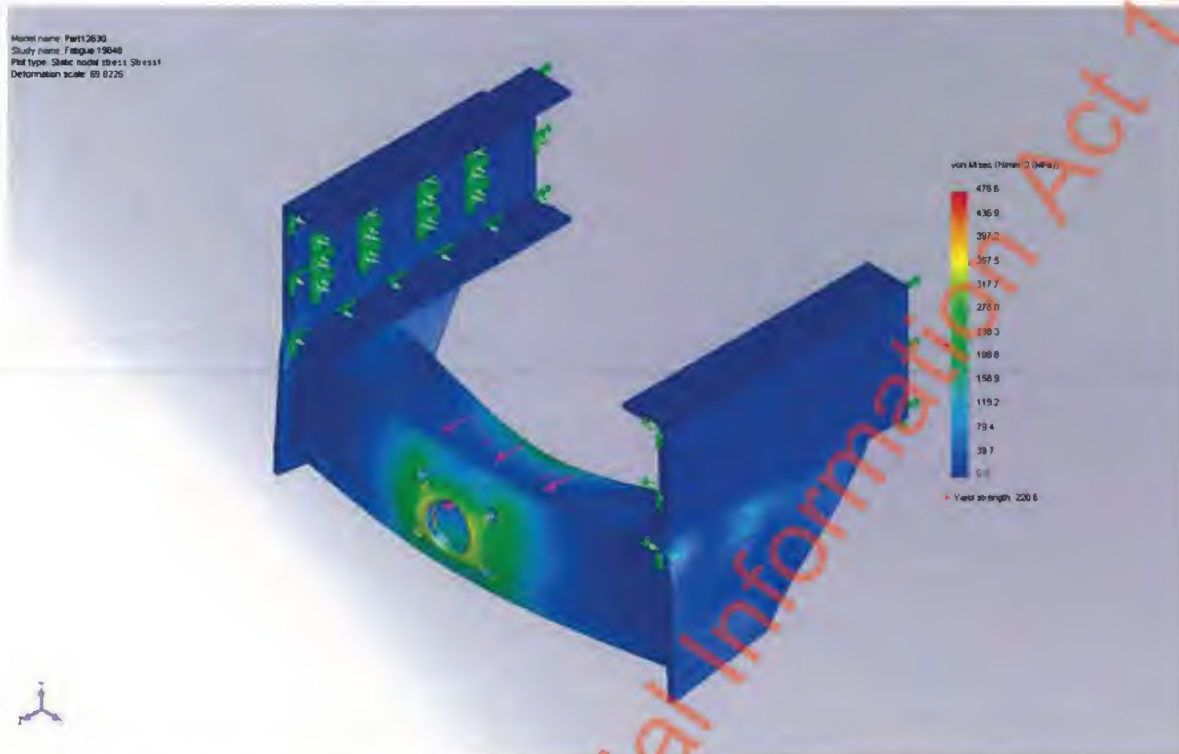
You did not include the following screen plot from analysis, but again stress levels being higher than 60% of yield.

This plot shows the loading as prescribed by NZS 5446 applied to the area bounded by the towing coupling flanges. This is not quite correct, as this area is clamped by the flanges. A more representative result would be obtained by applying this load as a rigidly applied load, or by modelling the actual coupling onto the drawbeam. However, both of these methods have drawbacks. It can be shown that so long as the section being bolted through is at least 16mm thick, there is no problem in the section of the drawbeam contained within the coupling flange meeting NZS 5446 loading. In analysing this plot, therefore, the stresses bounded by the coupling flange may be ignored. In this case, it can be seen that drawbeam stresses are actually within the 60% threshold of Yield Stress.

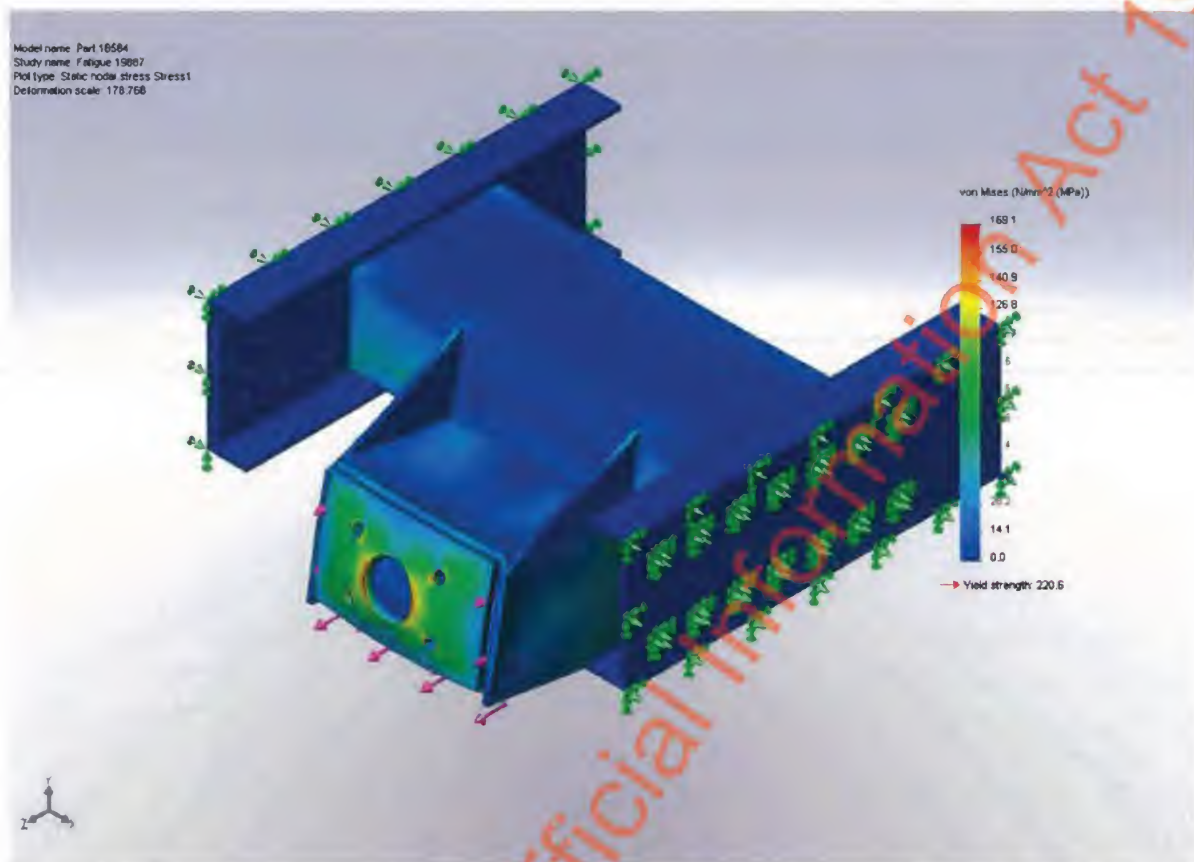
You did not include the following screen plot from analysis, but again stress levels being higher than 60% of yield.

This plot shows the loading as prescribed by NZS 5446 applied to the area bounded by the towing coupling flanges. This is not quite correct, as this area is clamped by the flanges. A more representative result would be obtained by applying this load as a rigidly applied load, or by modelling the actual coupling onto the drawbeam. However, both of these methods have drawbacks. It can be shown that so long as the section being bolted through is at least 16mm thick, there is no problem in the section of the drawbeam contained within the coupling flange meeting NZS 5446 loading. In analysing this plot, therefore, the stresses bounded by the coupling flange may be ignored. In this case, it can be seen that drawbeam stresses are actually within the 60% threshold of Yield Stress.

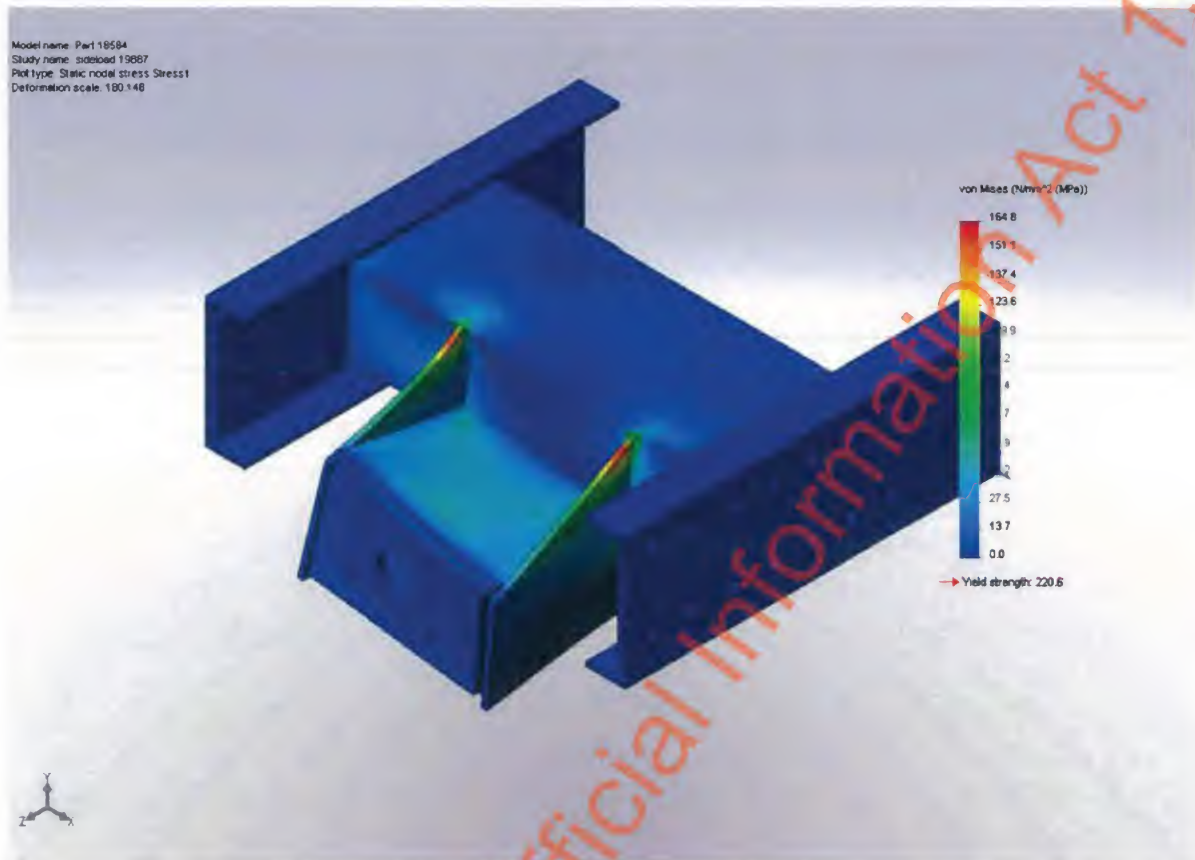
You raised the query on the Side Load Analysis on the above drawbeam, noting in the attached Diagram that the analysed stress was 165 mPa, higher than the 60% of yield for 220 mPa material.

This was in small surface areas of the Gussets. Although the analysis was carried out for 220 mPa yield, manufacture for this new drawbeam was from 300 mPa Yield plate, so this design was accepted as being within the allowable limits.

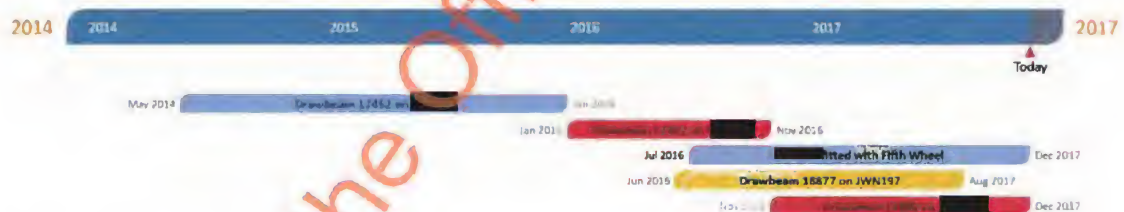
Figure 1 Towing connection history

The towing connection fitted to [REDACTED] on the 5<sup>th</sup> of January 2016, design 17452, is compared with a similar design which failed in service on the 27<sup>th</sup> of August 2017 while fitted to JWN197.

Reportedly the 17452-design failed while fitted to [REDACTED] and Peter Wastney certified a replacement drawbeam on the 8<sup>th</sup> of November 2016, design 19288. Drawbeam 17452 was initially fitted to [REDACTED] on the 29<sup>th</sup> of May 2014 before being moved to [REDACTED] in January 2016.

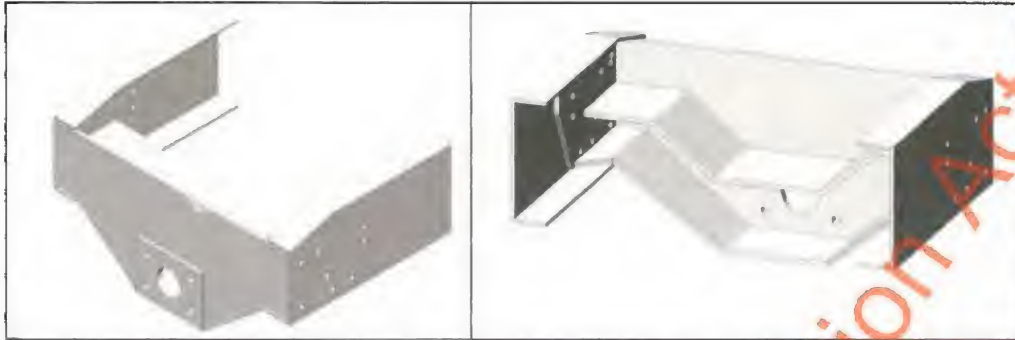
Figure 2 Drawbeam design 17452, Isometric view (left), Isometric view rear (right)

The drawbeam was certified on [REDACTED] in January 2016 before being replaced due to failure after approximately 40,000km of service on the 8<sup>th</sup> of December 2016. The total approximate service life of the drawbeam is 79,000km.

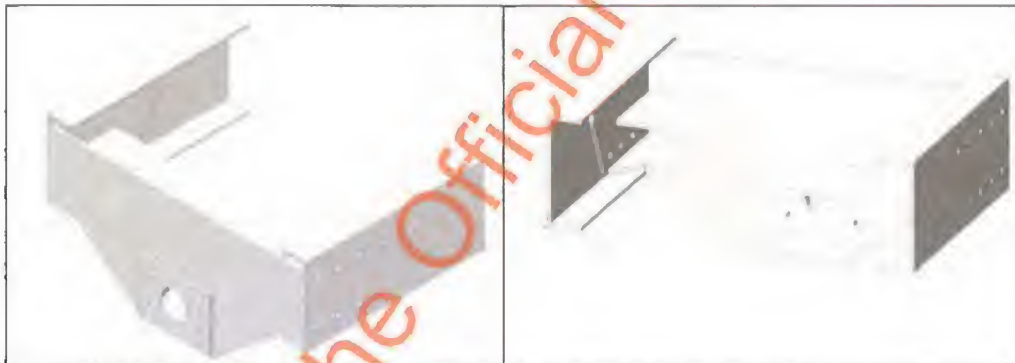
Figure 3 Drawbeam design 18877, Isometric view (left), Isometric view rear (right)

Drawbeam 18877 which failed on the 27<sup>th</sup> of August 2017 on JWN197, had travelled approximately 80,000 km. Basic design views are shown in Figure 3.
